**Flood Control Project Maintenance
Levee Inspections**

Fall 2015 Levee Maintenance Deficiency Summary Report

**Flood Control Project Maintenance
Levee Inspections**
LMA District Cover Sheet
Fall 2015 Levee Inspection Results

Sutter Maintenance Yard East-West Interceptor

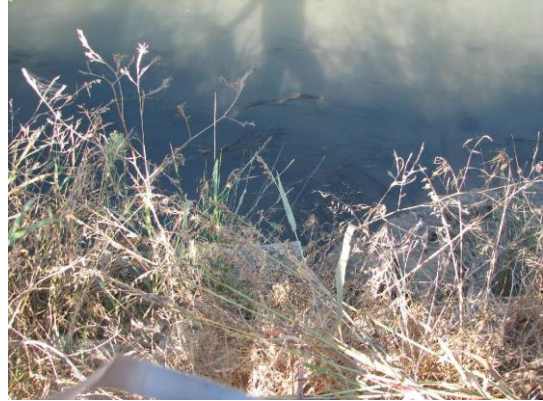
Photo 1 of 3 : UCIP_FA_2015_3516.jpg

LM Start	0.74	Rating **	M	Issue No.	38
LM End	0.74	Issue Type +	En	Location *	WS
Category	Supplemental			GPS Latitude/Longitude	
				Start	End
Item	DWR UCIP Field Study			39.170989 °	39.170989 °
				-121.712650 °	-121.712650 °
DWR ID	DWR_ST0020_02_f_2015_38				
Action/Comments					
Inspector Comments: FS_ID:45245					
DS_ID:19426					
EP_NO: N/A					
FS_HLM: 0.739					
Repair Type: Non-Urgent					
Crossing Status: Found

Concrete base along WS toe.

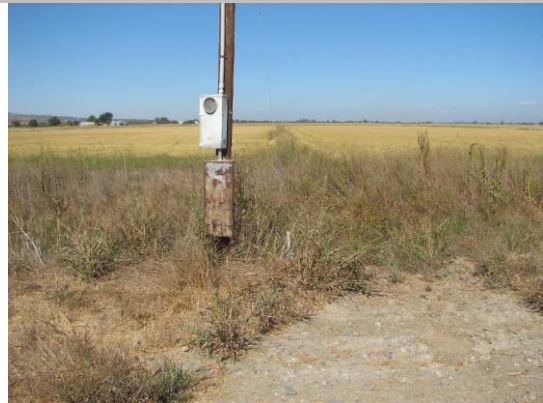
Photo 2 of 3 : UCIP_FA_2015_3517.jpg

Powerpole on WS shoulder.

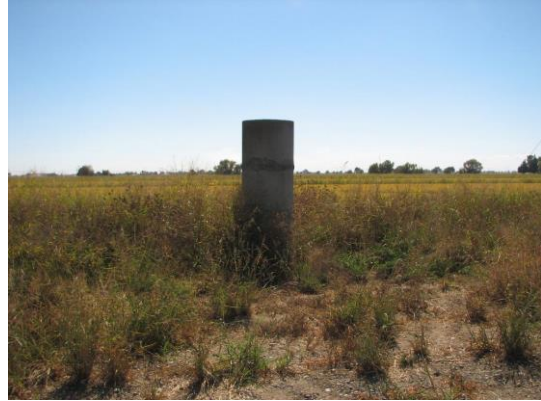
Photo 3 of 3 : UCIP_FA_2015_3518.jpg

LM Start	0.74	Rating **	M	Issue No.	38 (cont)
LM End	0.74	Issue Type +	En	Location *	WS
Category	Supplemental			GPS Latitude/Longitude	
				Start	End
Item	DWR UCIP Field Study			39.170989 °	39.170989 °
				-121.712650 °	-121.712650 °
DWR ID	DWR_ST0020_02_f_2015_38				
Action/Comments					
Inspector Comments: FS_ID:45245					
DS_ID:19426					
EP_NO: N/A					
FS_HLM: 0.739					
Repair Type: Non-Urgent					
Crossing Status: Found

Concrete standpipe on LS shoulder.

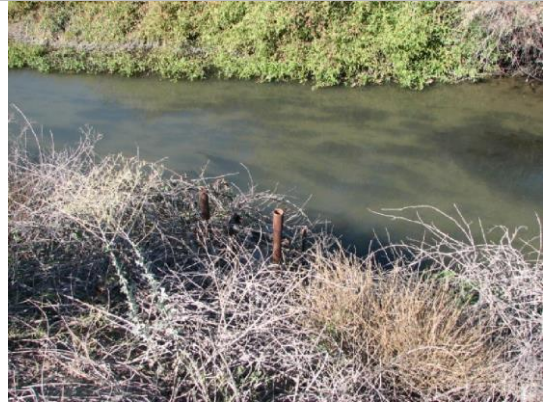
Photo 1 of 2 : UCIP_FA_2015_3559.jpg

LM Start	1.54	Rating **	M	Issue No.	37
LM End	1.54	Issue Type +	En	Location *	LS
Category	Supplemental			GPS Latitude/Longitude	
				Start	End
Item	DWR UCIP Field Study			39.170847 °	39.170847 °
				-121.697888 °	-121.697888 °
DWR ID	DWR_ST0020_02_f_2015_37				
Action/Comments					
Inspector Comments: FS_ID:45250					
DS_ID:19423					
EP_NO: N/A					
FS_HLM: 1.54					
Repair Type: Non-Urgent					
Crossing Status: Found

Pipe with flapgate at outlet on WS slope.

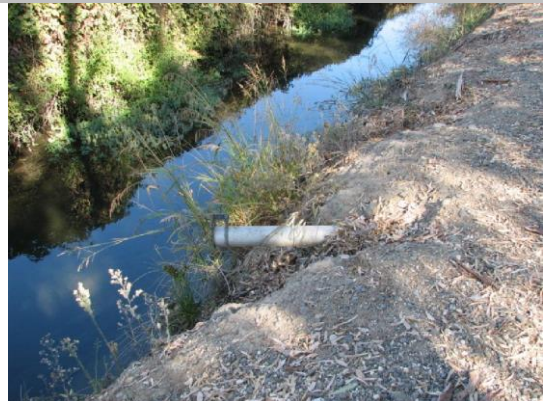
Photo 1 of 1 : UCIP_FA_2015_3561.jpg

LM Start	1.74	Rating **	M	Issue No.	36
LM End	1.74	Issue Type +	En	Location *	WS
Category	Supplemental			GPS Latitude/Longitude	
				Start	End
Item	DWR UCIP Field Study			39.170832 °	39.170832
				-121.694174 °	-121.694174
DWR ID	DWR_ST0020_02_f _ 2015_36				
Action/Comments					
Inspector Comments: FS_ID:45252					
DS_ID:20122					
EP_NO: N/A					
FS_HLM: 1.742					
Repair Type: Non-Urgent					
Crossing Status: Found

HDPE pipe on upstream side of aluminum pipe shown in picture.

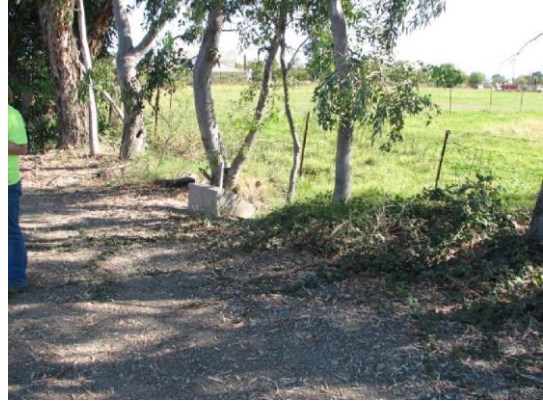
Photo 1 of 2 : UCIP_FA_2015_3564.jpg

Inspector Comments: FS_ID:45253
 DS_ID:20119
 EP_NO: N/A
 FS_HLM: 1.742
 Repair Type: Non-Urgent
 Crossing Status: Found
 UCIP Comments: 5/12/2015 Crossing appears in good condition. No noticeable issues to report.No permit identified for crossing.5/15/2013 Same as last inspection.11/4/2013 Same as last inspection.5/12/2014 Same as last inspection.11/17/2014 Same as last inspection.
 FIELD_STRUCT_DESC: 5-inch aluminum storm drain pipe through the levee 1-foot below the crown. Flap gate on water side with concrete headwall block on LS.
 FS Date: 05/14/2015

Concrete headwall on LS shoulder.

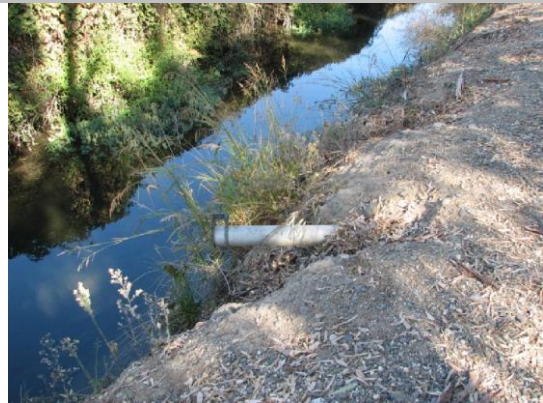
Photo 2 of 2 : UCIP_FA_2015_3565.jpg

pipe with flap gate on WS shoulder.

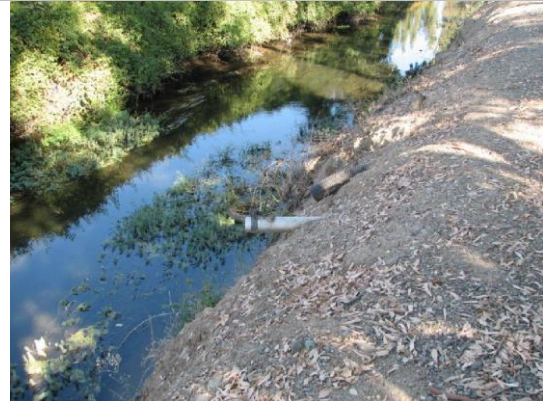
Photo 1 of 1 : UCIP_FA_2015_3876.jpg

LM Start	1.76	Rating **	M	Issue No.	33
LM End	1.76	Issue Type +	En	Location *	WS
Category	Supplemental			GPS Latitude/Longitude	
				Start	End
Item	DWR UCIP Field Study			39.170806 °	39.170806 °
				-121.693769 °	-121.693769 °
DWR ID	DWR_ST0020_02_f_2015_33				
Action/Comments					
Inspector Comments: FS_ID:45255					
DS_ID:20121					
EP_NO: N/A					
FS_HLM: 1.764					
Repair Type: Non-Urgent					
Crossing Status: Found

HDPE pipe on WS shoulder.

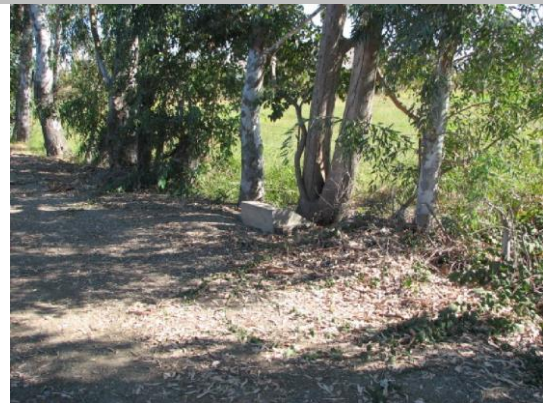
Photo 1 of 2 : UCIP_FA_2015_3562.jpg

LM Start	1.76	Rating **	M	Issue No.	34
LM End	1.76	Issue Type +	En	Location *	WS
Category	Supplemental			GPS Latitude/Longitude	
				Start	End
Item	DWR UCIP Field Study			39.170806 °	39.170806 °
				-121.693769 °	-121.693769 °
DWR ID	DWR_ST0020_02_f_2015_34				
Action/Comments					
Inspector Comments: FS_ID:45254 DS_ID:20120 EP_NO: N/A FS_HLM: 1.764 Repair Type: Non-Urgent Crossing Status: Found UCIP Comments: 5/12/2015 Crossing appears in good condition. No noticeable issues to report.No permit identified for crossing.5/15/2013 Same as last inspection.11/4/2013 Same as last inspection.5/12/2014 Same as last inspection.11/17/2014 Same as last inspection. FIELD_STRUCT_DESC: 5-inch aluminum storm drain pipe through the levee 1-foot below the crown. Flap gate on water side with concrete headwall block on LS. FS Date: 05/14/2015

Concrete headwall on LS shoulder.

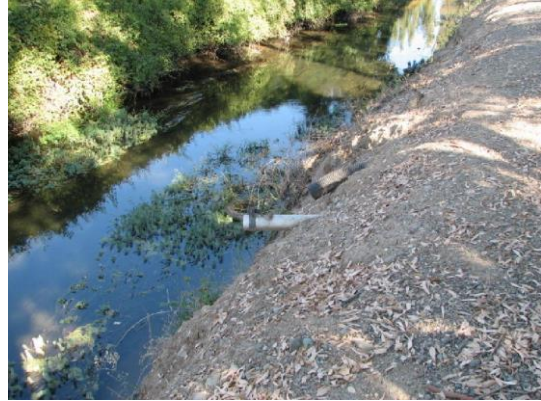
Photo 2 of 2 : UCIP_FA_2015_3563.jpg

Action/Comments					
Inspector Comments: FS_ID:45254 DS_ID:20120 EP_NO: N/A FS_HLM: 1.764 Repair Type: Non-Urgent Crossing Status: Found UCIP Comments: 5/12/2015 Crossing appears in good condition. No noticeable issues to report.No permit identified for crossing.5/15/2013 Same as last inspection.11/4/2013 Same as last inspection.5/12/2014 Same as last inspection.11/17/2014 Same as last inspection. FIELD_STRUCT_DESC: 5-inch aluminum storm drain pipe through the levee 1-foot below the crown. Flap gate on water side with concrete headwall block on LS. FS Date: 05/14/2015

Pipe and flap gate on WS shoulder.

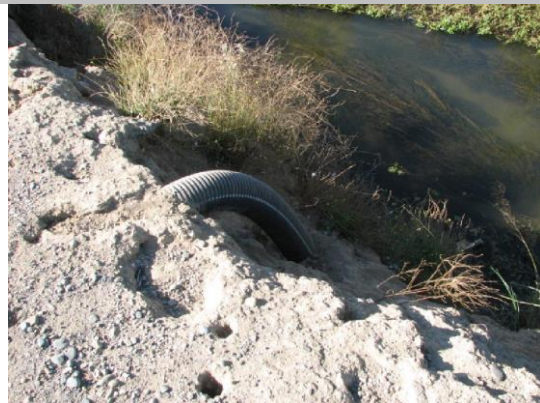
Photo 1 of 3 : UCIP_FA_2015_3870.jpg

LM Start	1.94	Rating **	M	Issue No.	32
LM End	1.94	Issue Type +	En	Location *	CR
Category	Supplemental			GPS Latitude/Longitude	
				Start	End
Item	DWR UCIP Field Study			39.170771 °	39.170771 °
				-121.690631 °	-121.690631 °
DWR ID	DWR_ST0020_02_f_ 2015_32				
Action/Comments					
Inspector Comments: FS_ID:45257					
DS_ID:20123					
EP_NO: N/A					
FS_HLM: 1.935					
Repair Type: Non-Urgent					
Crossing Status: Found					
UCIP Comments: 5/12/2015 Crossing appears in good condition. No noticeable issues to report.No permit identified for crossing.5/15/2013 Flexible pipe has been replaced with 6.5 inch steel with flap gate on WS. Erosion under WS outlet.5/22/2013 Erosion under pipe outlet has been repaired. Bank lined with rock to prevent future erosion.11/4/2013 Same as last inspection.5/12/2014 Same as last inspection.11/17/2014 Same as last inspection.					
FIELD_STRUCT_DESC: 7-inch flexible HDPE storm drain pipe through the levee 1-foot below the crown.

Outlet for crossing on WS shoulder.

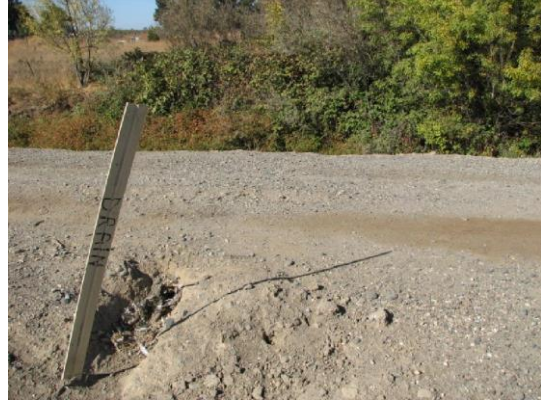
Photo 2 of 3 : UCIP_FA_2015_3871.jpg

LM Start	1.94	Rating **	M	Issue No.	32 (cont)	
LM End	1.94	Issue Type +	En	Location *	CR	
Category	Supplemental			GPS Latitude/Longitude		
				Start	End	
Item	DWR UCIP Field Study			39.170771 °	39.170771 °	
				-121.690631 °	-121.690631 °	
DWR ID	DWR_ST0020_02_f_2015_32					
Action/Comments						
Inspector Comments: FS_ID:45257 DS_ID:20123 EP_NO: N/A FS_HLM: 1.935 Repair Type: Non-Urgent Crossing Status: Found UCIP Comments: 5/12/2015 Crossing appears in good condition. No noticeable issues to report.No permit identified for crossing.5/15/2013 Flexible pipe has been replaced with 6.5 inch steel with flap gate on WS. Erosion under WS outlet.5/22/2013 Erosion under pipe outlet has been repaired. Bank lined with rock to prevent future erosion.11/4/2013 Same as last inspection.5/12/2014 Same as last inspection.11/17/2014 Same as last inspection. FIELD_STRUCT_DESC: 7-inch flexible HDPE storm drain pipe through the levee 1-foot below the crown. FS Date: 05/14/2015

Inlet and signage for crossing on LS shoulder.

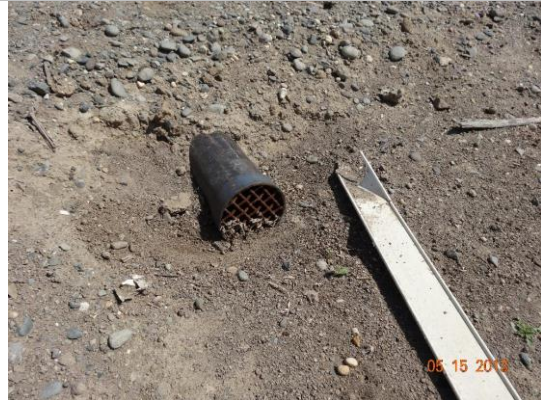
Photo 3 of 3 : UCIP_FA_2015_3872.jpg

Pipe end with grate on LS.

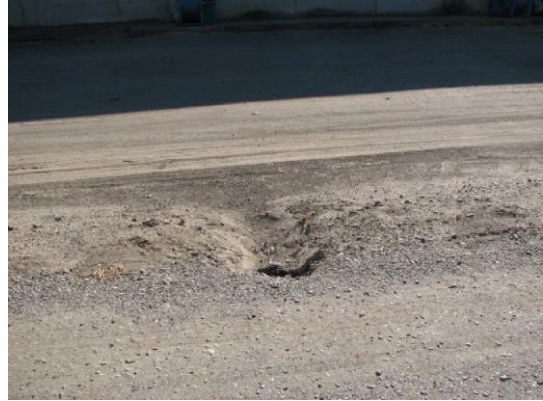
Photo 1 of 3 : UCIP_FA_2015_3873.jpg

LM Start	1.98	Rating **	M	Issue No.	31
LM End	1.98	Issue Type +	En	Location *	CR
Category	Supplemental			GPS Latitude/Longitude	
				Start	End
Item	DWR UCIP Field Study			39.170754 °	39.170754 °
				-121.689815 °	-121.689815 °
DWR ID	DWR_ST0020_02_f_2015_31				
Action/Comments					
Inspector Comments: FS_ID:45258 DS_ID:20124 EP_NO: N/A FS_HLM: 1.979 Repair Type: Non-Urgent Crossing Status: Found UCIP Comments: 5/12/2015 Crossing appears in good condition. No noticeable issues to report.No permit identified for this crossing.5/15/2013 Flexible pipe has been replaced with 6.5 inch steel with flap gate on WS outlet. Erosion under WS outlet.5/22/2013 Erosion under pipe outlet has been repaired and bank lined with rock to prevent future erosion.11/4/2013 Same as last inspection.5/12/2014 Same as last inspection.11/17/2014 Same as last inspection. FIELD_STRUCT_DESC: 7-inch flexible HDPE storm drain pipe through the levee 1-foot below the crown. FS Date: 05/14/2015

Pipe on LS shoulder.

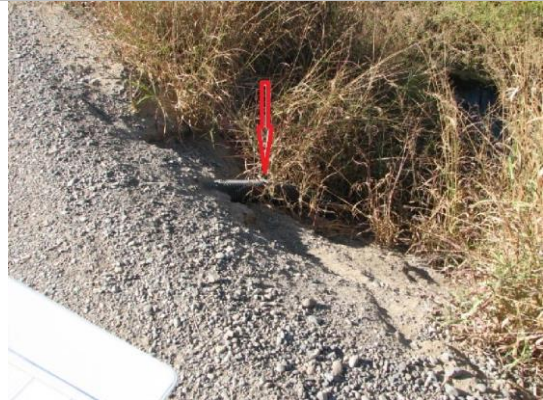
Photo 2 of 3 : UCIP_FA_2015_3874.jpg

Pipe on WS shoulder.

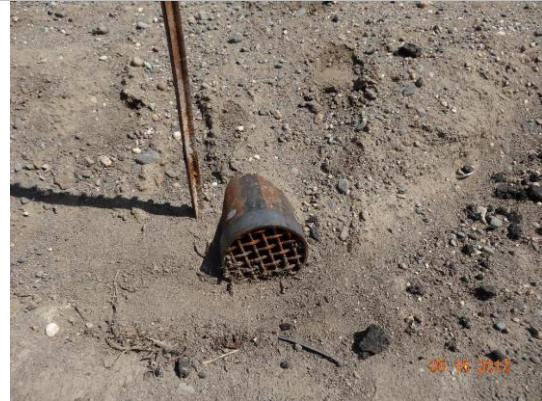
Photo 3 of 3 : UCIP_FA_2015_3875.jpg

LM Start	1.98	Rating **	M	Issue No.	31 (cont)
LM End	1.98	Issue Type +	En	Location *	CR
Category	Supplemental			GPS Latitude/Longitude	
				Start	End
Item	DWR UCIP Field Study			39.170754 °	39.170754
				-121.689815 °	-121.689815
DWR ID	DWR_ST0020_02_f_2015_31				
Action/Comments					
Inspector Comments: FS_ID:45258					
DS_ID:20124					
EP_NO: N/A					
FS_HLM: 1.979					
Repair Type: Non-Urgent					
Crossing Status: Found

LS intake with grate.

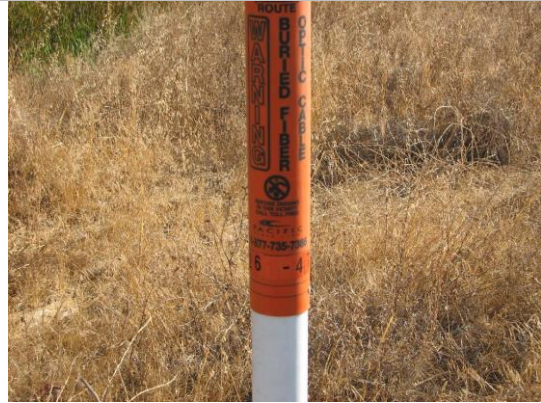
Photo 1 of 2 : UCIP_FA_2015_3877.jpg

Inspector Comments: FS_ID:45261
 DS_ID:20125
 EP_NO: N/A
 FS_HLM: 2.045
 Repair Type: Non-Urgent
 Crossing Status: Found
 UCIP Comments: 5/12/2015 Crossing appears in good condition. No noticeable issues to report.No permit identified for this crossing.5/15/2013 Same as last inspection.11/4/2013 Same as last inspection.5/12/2014 Same as last inspection.11/17/2014 Same as last inspection.
 FIELD_STRUCT_DESC: Fiber optic line throught the levee at unknown depth crossing on east side of Township road bridge.
 FS Date: 05/14/2015

Closeup of marker.

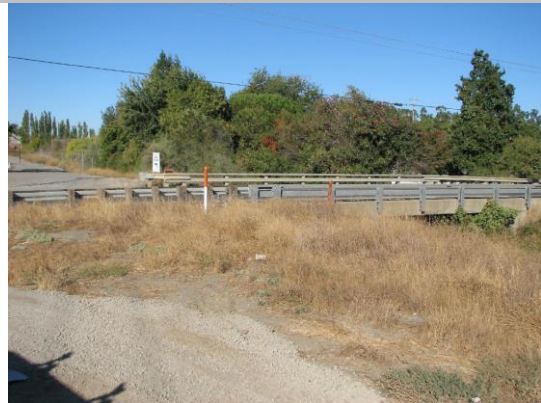
Photo 2 of 2 : UCIP_FA_2015_3878.jpg

Marker on east side of N Township Drive, south of interceptor.

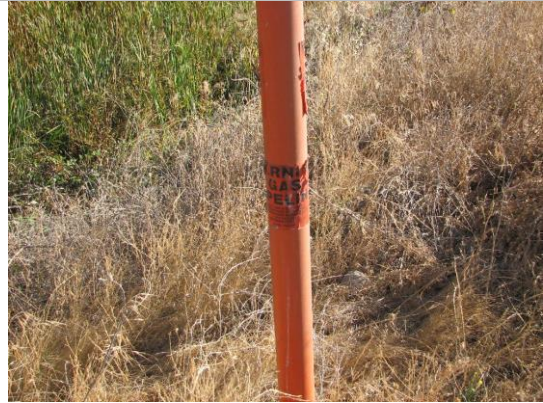
Photo 1 of 3 : UCIP_FA_2015_3879.jpg

LM Start	2.05	Rating **	M	Issue No.	29
LM End	2.05	Issue Type +	En	Location *	WS
Category	Supplemental			GPS Latitude/Longitude	
				Start	End
Item	DWR UCIP Field Study			39.170708 °	39.170708 °
				-121.688566 °	-121.688566 °
DWR ID	DWR_ST0020_02_f_2015_29				
Action/Comments					
Inspector Comments: FS_ID:45262					
DS_ID:20126					
EP_NO: N/A					
FS_HLM: 2.046					
Repair Type: Non-Urgent					
Crossing Status: Found

gasline marker.

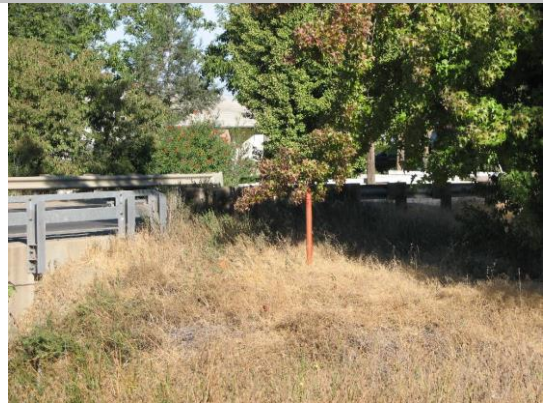
Photo 2 of 3 : UCIP_FA_2015_3880.jpg

Gasline marker on east side of N Township Road North of interceptor

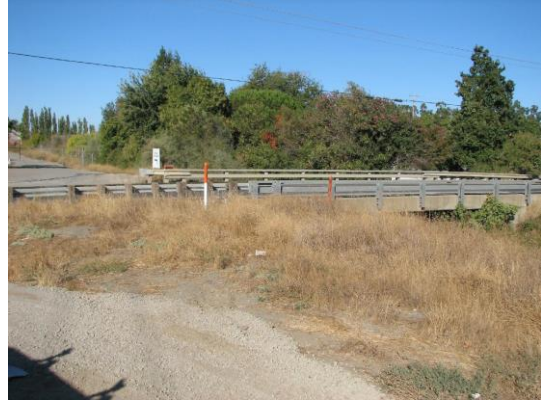
Photo 3 of 3 : UCIP_FA_2015_3881.jpg

LM Start	2.05	Rating **	M	Issue No.	29 (cont)	
LM End	2.05	Issue Type +	En	Location *	WS	
Category	Supplemental			GPS Latitude/Longitude		
				Start	End	
Item	DWR UCIP Field Study			39.170708 °	39.170708	
				-121.688566 °	-121.688566	
DWR ID	DWR_ST0020_02_f_2015_29					
Action/Comments						
Inspector Comments: FS_ID:45262						
DS_ID:20126						
EP_NO: N/A						
FS_HLM: 2.046						
Repair Type: Non-Urgent						
Crossing Status: Found

Gasline marker on east side of N Township Road south of interceptor

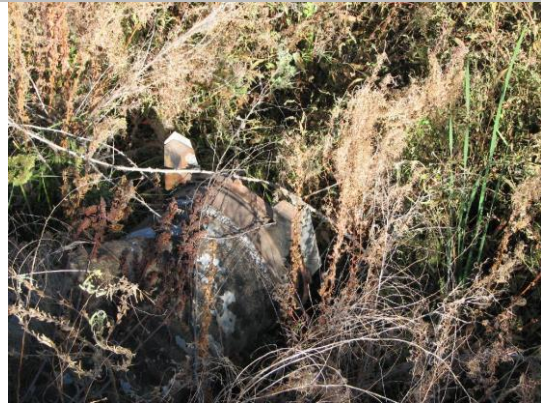
Photo 1 of 3 : UCIP_FA_2015_3882.jpg

LM Start	2.05	Rating **	M	Issue No.	28
LM End	2.05	Issue Type +	En	Location *	WS
Category	Supplemental			GPS Latitude/Longitude	
				Start	End
Item	DWR UCIP Field Study			39.170639 °	39.170639
				-121.688445 °	-121.688445
DWR ID	DWR_ST0020_02_f_2015_28				
Action/Comments					
Inspector Comments: FS_ID:45263 DS_ID:20127 EP_NO: N/A FS_HLM: 2.053 Repair Type: Non-Urgent Crossing Status: Found UCIP Comments: 5/12/2015 Crossing appears in good condition. No noticeable issues to report.No permit identified for this crossing.5/15/2013 Same as last inspection.11/4/2013 Same as last inspection.5/12/2014 Same as last inspection.11/17/2014 Same as last inspection. FIELD_STRUCT_DESC: 18-inch asphalt coated corrugated metal storm drain pipe through the levee 6-feet below the crown. Flap gate on water side. FS Date: 05/14/2015

Flap gate on WS slope.

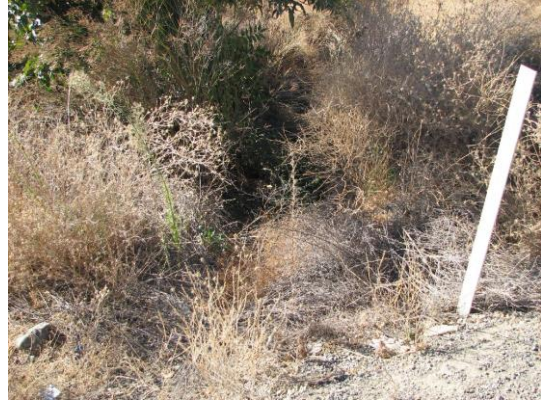
Photo 2 of 3 : UCIP_FA_2015_3912.jpg

Inspector Comments: FS_ID:45263
 DS_ID:20127
 EP_NO: N/A
 FS_HLM: 2.053
 Repair Type: Non-Urgent
 Crossing Status: Found
 UCIP Comments: 5/12/2015 Crossing appears in good condition. No noticeable issues to report.No permit identified for this crossing.5/15/2013 Same as last inspection.11/4/2013 Same as last inspection.5/12/2014 Same as last inspection.11/17/2014 Same as last inspection.
 FIELD_STRUCT_DESC: 18-inch asphalt coated corrugated metal storm drain pipe through the levee 6-feet below the crown. Flap gate on water side.
 FS Date: 05/14/2015

Location of pipe on LS toe.

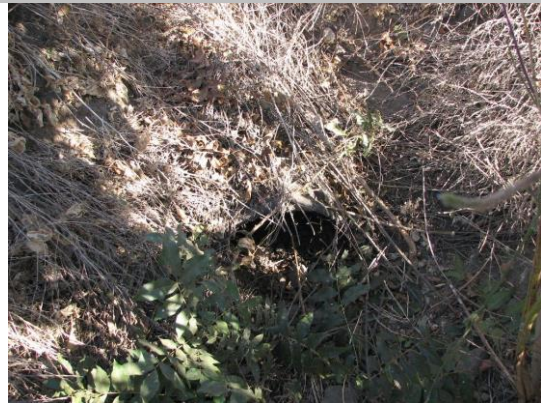
Photo 3 of 3 : UCIP_FA_2015_3913.jpg

Pipe on LS toe.
